# P.2.24 Release Notes

**aruba**

Part Number: 5200-7097  
Published: April 2020  
Edition: 1

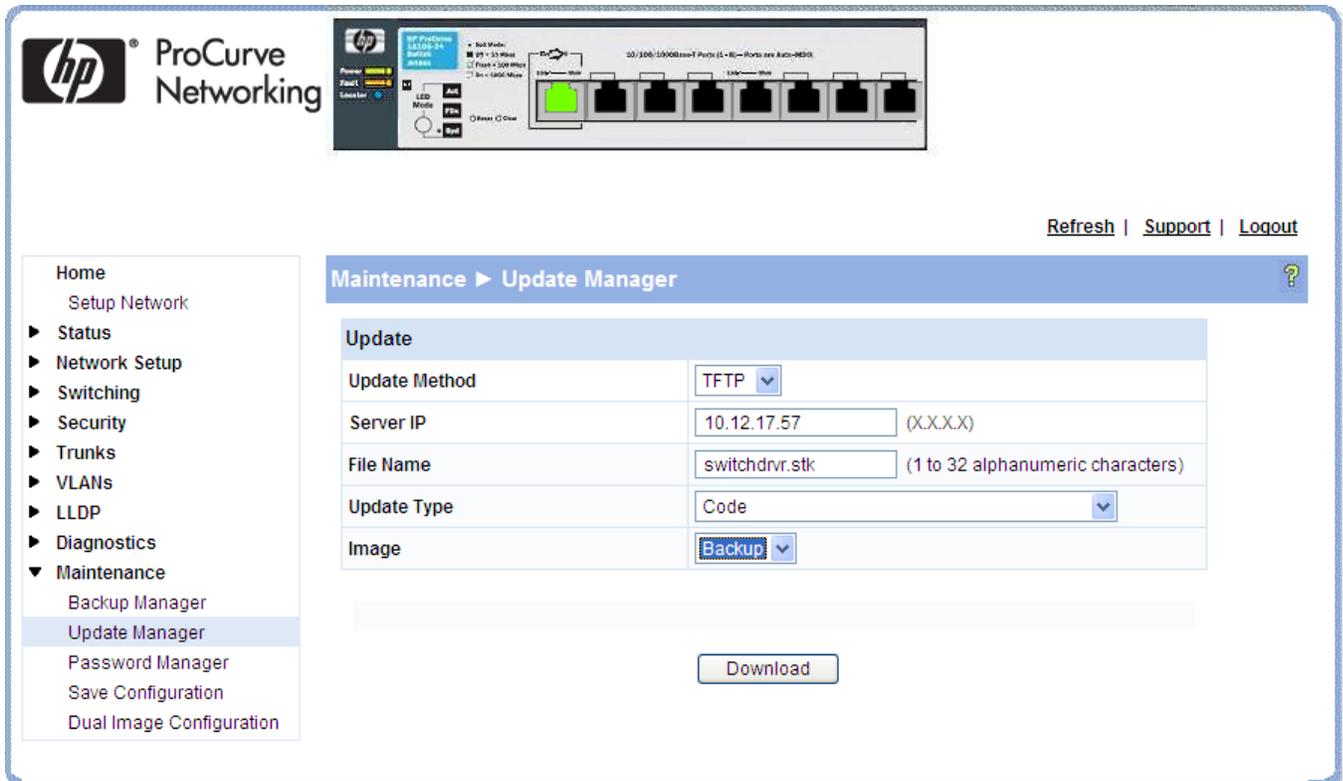
**Figure 1:** Update Manager page

Update Manager displays different options depending on the transfer protocol, file, or image type selected for an update. In the example in **Figure 1: Update Manager page**, the inactive (or Backup) image on the switch is being updated with the file named `switchdrvr.stk` from a TFTP server. For example, if the `image1` file is being used as the currently-active image running on the switch, then `image2` is the backup image file to be updated. To check the software version in each image, and to determine which image is currently active, use the **Status > Dual Image** screen.

Field	Description
<b>Update Method</b>	Select the protocol to use: <ul style="list-style-type: none"> <li><b>HTTP</b> <ul style="list-style-type: none"> <li>The file is downloaded using HTTP from a local or remote drive.</li> </ul> </li> <li><b>TFTP</b> <ul style="list-style-type: none"> <li>The file is downloaded using TFTP from a TFTP server operating on the system/network.</li> </ul> </li> </ul>
<b>Browse for file</b> (HTTP download)	If HTTP is used for the software download, click <b>Browse</b> to select the designated file. <p>

3. In the Update Type field, select **Code**.
4. In the **Image** field, choose **Backup** or **Active**.
5. If you choose **Backup**, the inactive (backup) image file will be updated. In the example in **Figure 1: Update Manager page**, the Backup image file is selected for update.

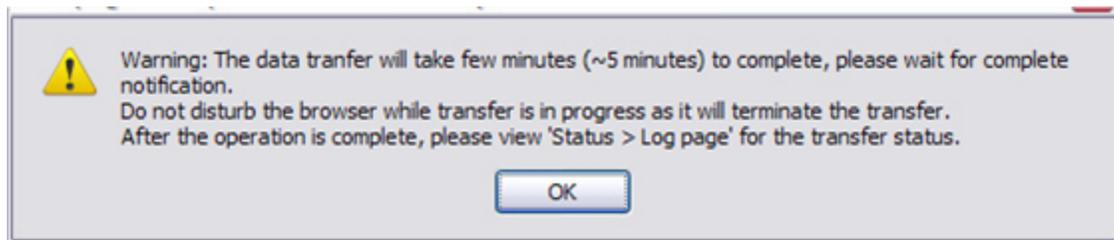
7. Click **Download**.
8. A warning page like the following displays (the text may differ depending on the protocol selected):

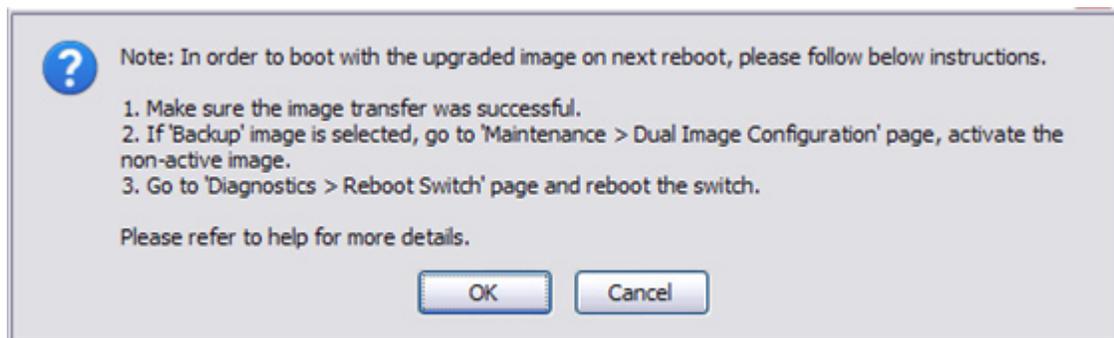
9. Click **OK**.
10. The following page displays.

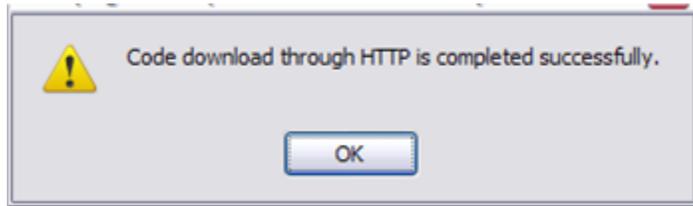
11. Click **OK**.
12. A download in progress page displays. When the transfer is complete, a window like the following displays:

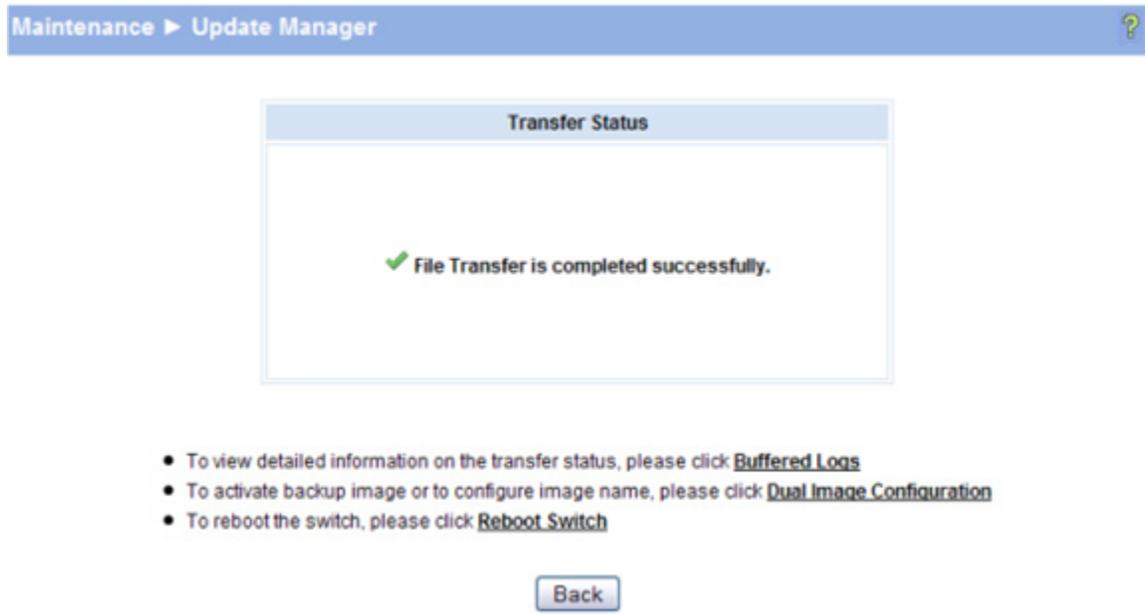
13. Click **OK**.
14. Update Manager displays the following status message:

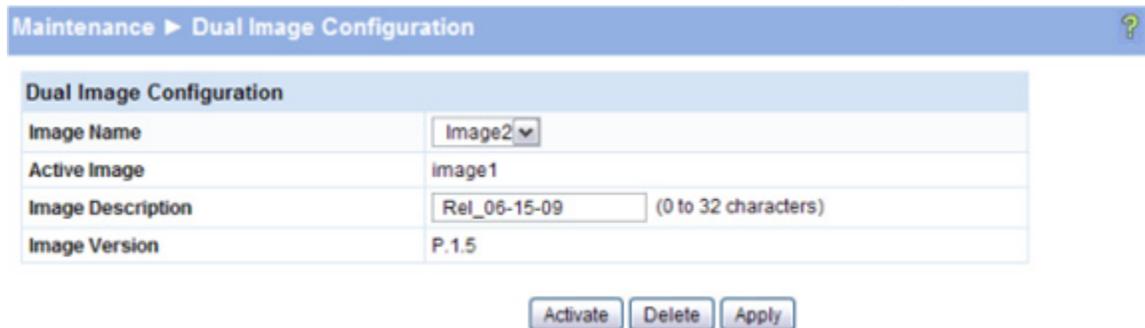
15. Click **Back** to redisplay the **Update Manager** page.
16. In this example, the image was downloaded as the inactive (backup) image. To complete the update process and to activate the backup image as the operating software, use the **Dual Image Configuration** page.
17. In the next figure, Image1 is the active image and is the newly updated backup image. Image2 is to be activated on the next reboot (and Image1 will become the inactive backup image).

18. (Optional) Add a description for the selected image (Image2) and click **Apply**.
19. Click **Activate** to activate the selected image on the next reboot.
20. You can verify the next active image prior to rebooting the switch by viewing the **Status > Dual Image** screen.

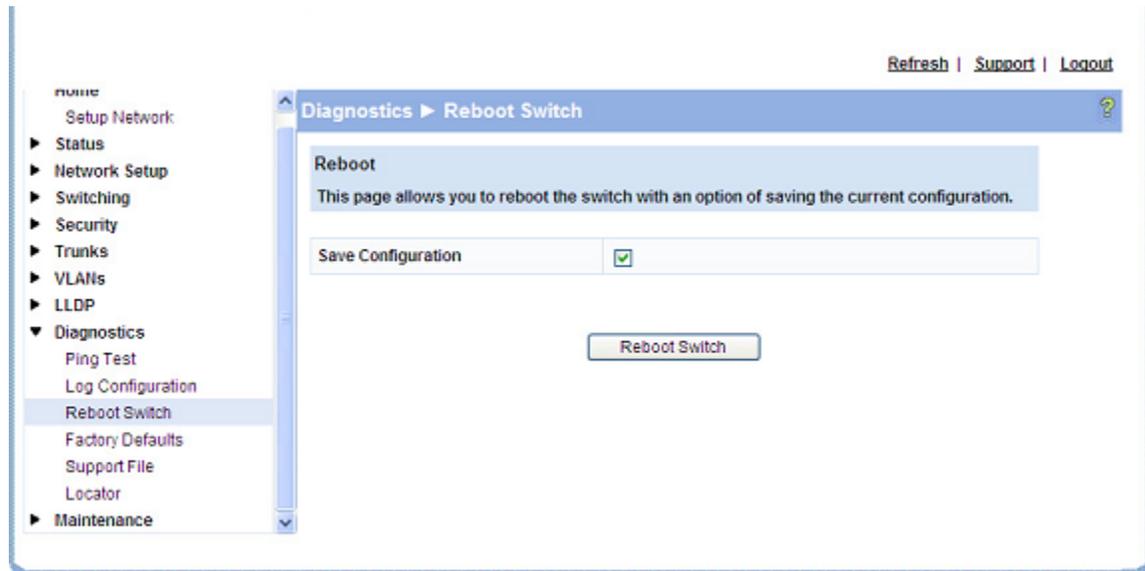
21. Click **Diagnostics** > **Reboot Switch**, and then click **Reboot Switch** to complete the update.

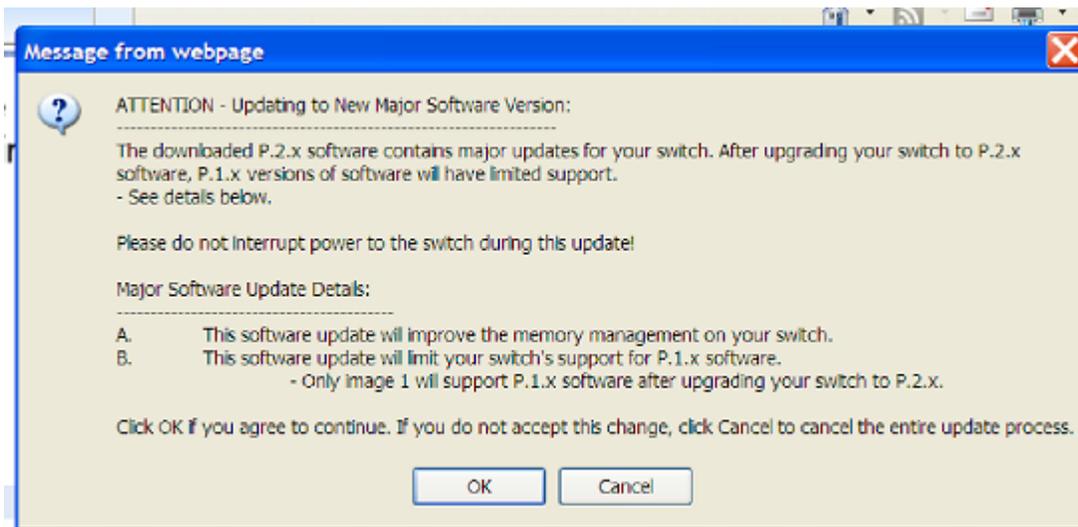
1. Update to P.2.x (on Image2) following the procedure described above. Once P.2.x has been downloaded, the message in the next figure is displayed.

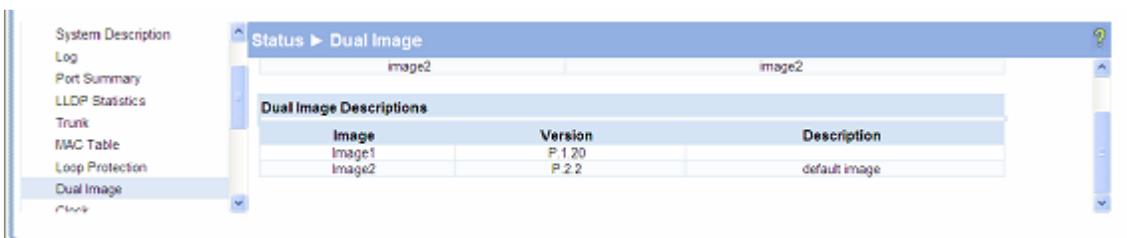
2. After the download, activate P.2.x and reboot the switch. At this point you can verify the switch software versions by viewing the **Status > Dual Image** screen (next figure).

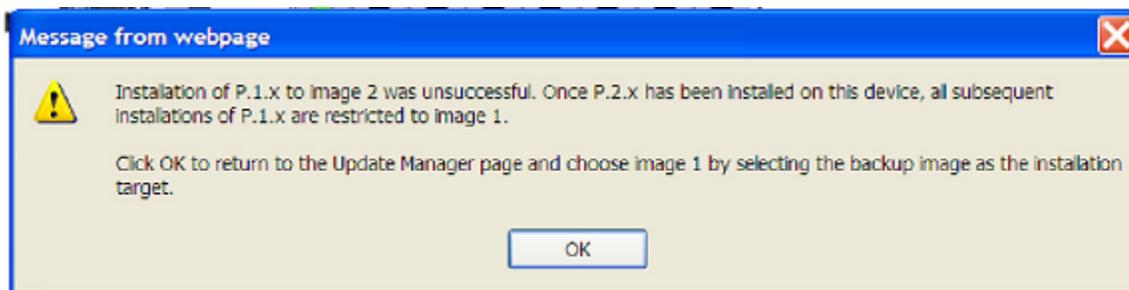
As long as Image1 has P.1.20 installed, any attempt to load P.1.x to Image2 will fail with the following message displayed:

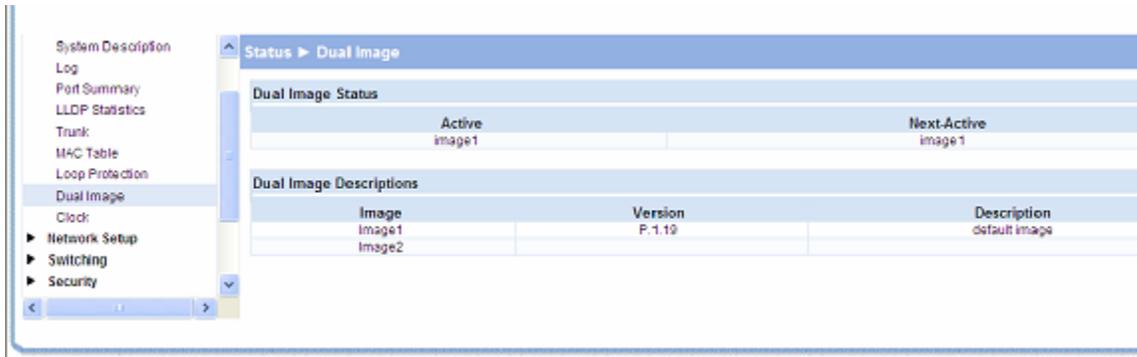
Once you have successfully downgraded switch software by downloading P.1.x (where x <=19) to Image1, activating Image1, and booting into P.1.x on Image1, the switch can no longer recognize the P.2.x software

loaded on Image2. The **Status > Dual Image** screen shows the following even though P.2.x is still installed on Image2.

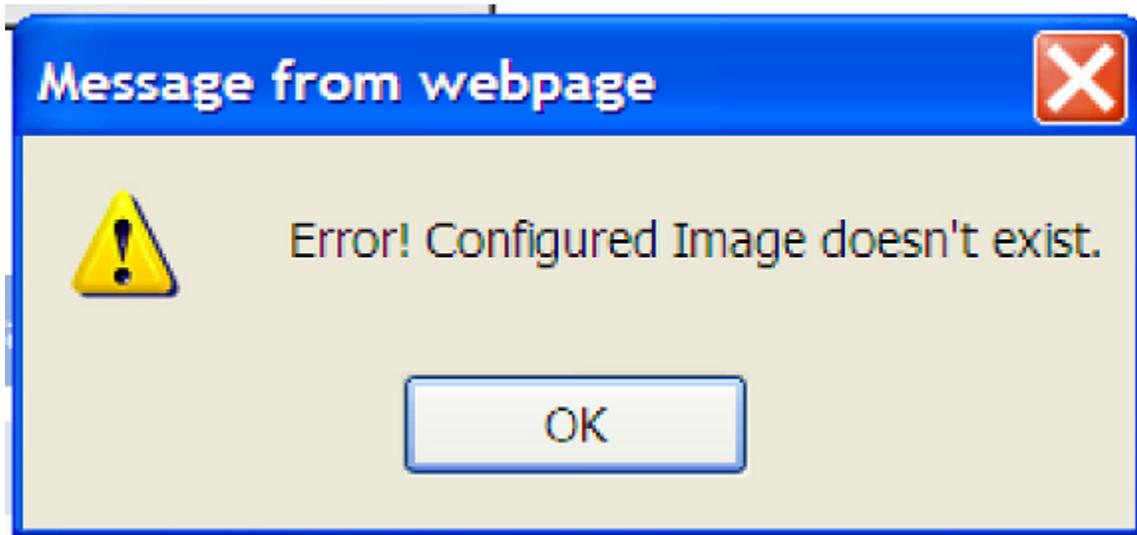
In this situation, Image2 cannot be updated, activated, or deleted. If you try to activate Image2 from the **Maintenance > Dual Image Configuration** screen, the following message is displayed:

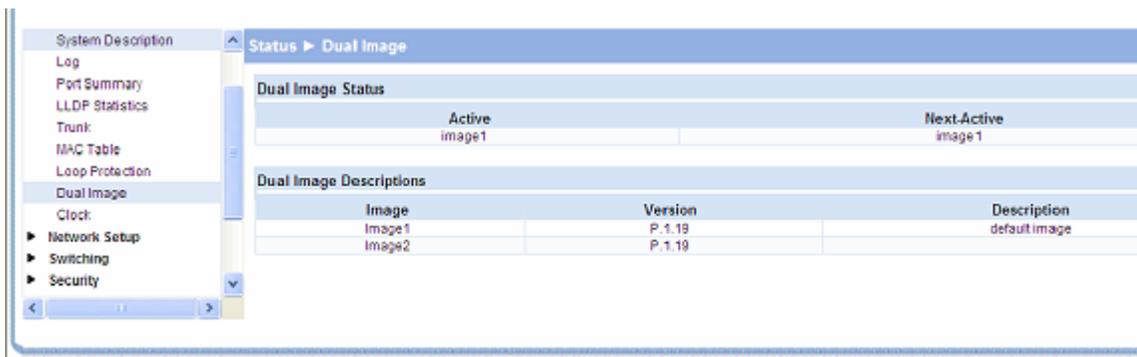
If you now attempt to load P.1.x to Image2, the download appears to work. For example, if you download P. 1.19 on Image2, with P.1.19 already on Image1, the **Status > Dual Image** screen shows the following before Image2 is activated and the switch is rebooted.
